Pilot Construction Project for Granular Shoulder Stabilization

Iowa Highway Research Board
(IHRB Project TR-634)
Iowa Department of Transportation
(InTrans Project 11-405)

tech transfer summary

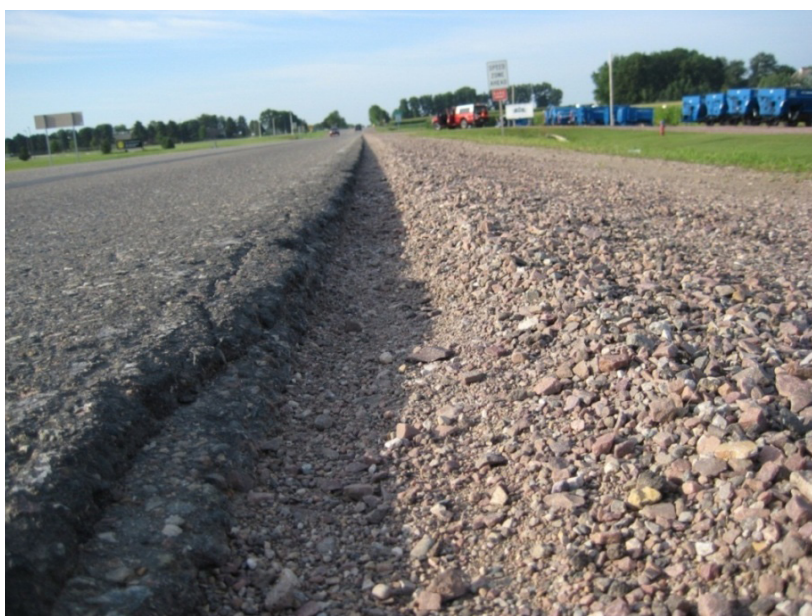
Edge rutting on granular shoulder (Jahren et al. 2011)

Edge rutting on granular shoulders is a serious traffic safety issue because it can cause vehicles to run off the road, which can lead to loss of control and even loss of life (Jahren et al. 2011). Edge rutting is caused by three factors: wind and air currents, vehicle off-tracking, and drainage.

Over time, wind and air currents from large vehicles blow fine material away from the shoulder, exposing large particles on the shoulder surface, which are removed more easily by vehicle off-tracking. Off-tracking refers to the situation where rear tires run a different path from front tires during vehicle turning movements. Pavement drainage accumulates along the pavement edge and makes shoulder materials unstable.

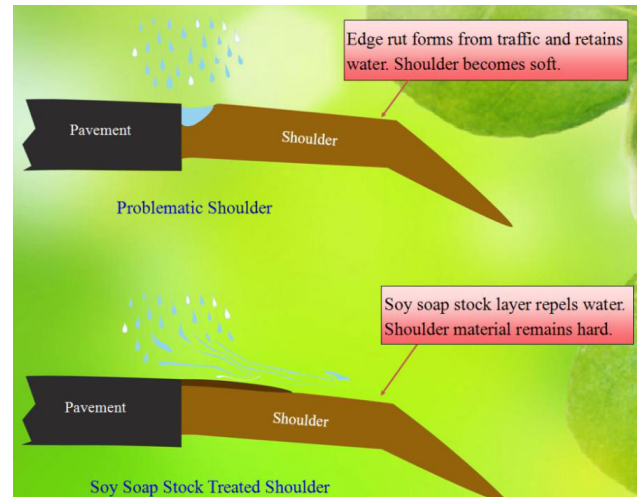
Stabilization of granular shoulders with soybean oil soapstock
